Mansfield, Lois (2018) The geology of High Borrowdale. Conserving Lakeland, 77 . pp. 8-9.

# The Geology of High Borrowdale

We talked in the last edition of *Conserving Lakeland* about a research project looking into the effectiveness of a new landscape stabilisation matting called sisal. We asked Dr Lois Mansfield from the University of Cumbria to give us an overview of the work ahead this year, the thinking behind the approach and a little more detail about the geology of the area and the challenges we face.

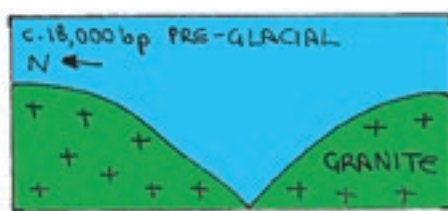
### 1 The impermeable geology of High Borrowdale

High Borrowdale has a geology which is generally of an impermeable nature.

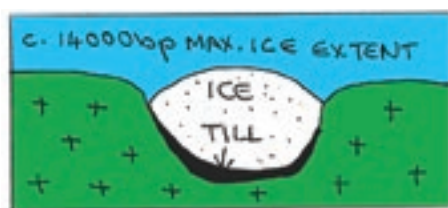
### 2 A glacier carves a trough using debris carried in the ice

Into this landscape a glacier carved a trough using debris carried in the ice cutting roughly east to west out from the central Lakes, probably around 22,000 to 14,000 years ago.

This eroded material was plastered on the floor of the glacier and lodged on the sides constituting various jumbled sizes, from boulders over 1m to fine clays less than 0.002mm. As the ice retreated from that time, additional debris (till) that the glacier was carrying was dumped into the valley bottom and smeared up the sides to form a tapering thick layer (about 20m deep).

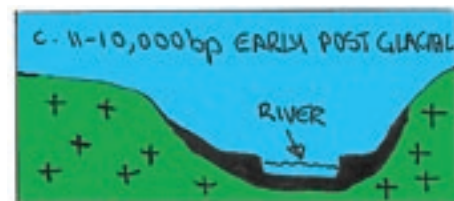
### 3 Retreating ice cap forms a raging post glacial river

As the central ice cap of the Lake District melted, valleys like High Borrowdale allowed millions of litres of water to exit and as it did so cut down through the glacial till forming a raging post glacial river.

This river shifted thousands of tonnes of the unconsolidated sediment down into the Lune gorge and out eventually into Morecambe Bay.

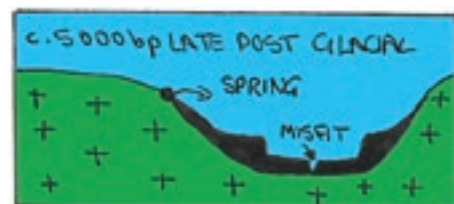
### 4 As flow decreases a contemporary misfit river is left

Gradually the flow decreased and we were left with the contemporary misfit river from about 10,000 years ago.

This has created a much smaller floodplain within the valley bottom and the river meanders back and forth across the valley bottom regularly undercutting the banks created by the earlier post glacial river.

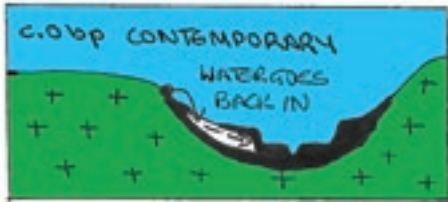
### 1 High Spring Line

The first is the existence of a spring line high up on the sides of the south facing slope.

Because the bedrock is impermeable, water is coming out of the ground onto the surface in the allotment land. Until, that is, it hits the tapered till deposits on the sides of valley, and then the water is sinking back into the unconsolidated material saturating it, making it unstable.
