Mansfield, Lois ORCID: <https://orcid.org/0000-0002-0707-2467> (2018) The geology of High Borrowdale. *Conserving Lakeland*, 77 . pp. 8-9.

# The Geology of High Borrowdale

We talked in the last edition of *Conserving Lakeland* about a research project looking into the effectiveness of a new landscape stabilisation matting called sisal. We asked Dr Lois Mansfield from the University of Cumbria to give us an overview of the work ahead this year, the thinking behind the approach and a little more detail about the geology of the area and the challenges we face.

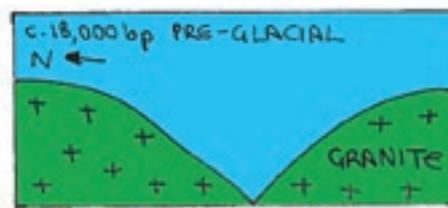
### 1 The impermeable geology of High Borrowdale

High Borrowdale has a geology which is generally of an impermeable nature.

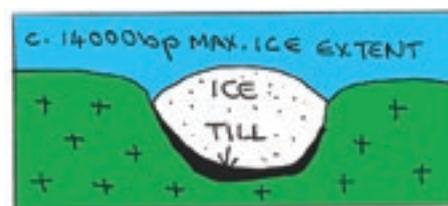
### 2 A glacier carves a trough using debris carried in the ice

Into this landscape a glacier carved a trough using debris carried in the ice cutting roughly east to west out from the central Lakes, probably around 22,000 to 14,000 years ago.

This eroded material was plastered on the floor of the glacier and lodged on the sides constituting various jumbled sizes, from boulders over 1m to fine clays less than 0.002mm. As the ice retreated from that time, additional debris (till) that the glacier was carrying was dumped into the valley bottom and smeared up the sides to form a tapering thick layer (about 20m deep).

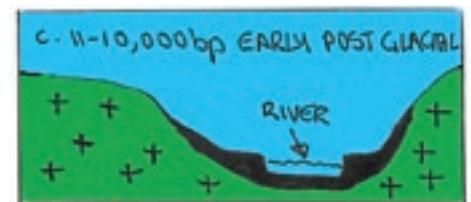
### 3 Retreating ice cap forms a raging post glacial river

As the central ice cap of the Lake District melted, valleys like High Borrowdale allowed millions of litres of water to exit and as it did so cut down through the glacial till forming a raging post glacial river.

This river shifted thousands of tonnes of the unconsolidated sediment down into the Lune gorge and out eventually into Morecambe Bay.

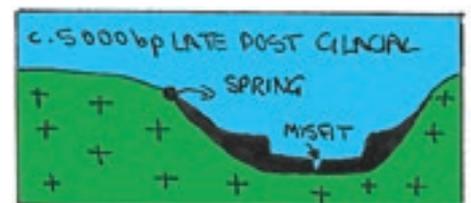
### 4 As flow decreases a contemporary misfit river is left

Gradually the flow decreased and we were left with the contemporary misfit river from about 10,000 years ago.

This has created a much smaller floodplain within the valley bottom and the river meanders back and forth across the valley bottom regularly undercutting the banks created by the earlier post glacial river.
